**DEPARTMENT OF TRANSPORTATION**

Contract #: 04-0120F4Cty: SF/ALA Rte: 80 PM: 13.2/13.9File #: 1.28**WELDING INSPECTION REPORT****Resident Engineer:** Casey, William**Address:** 333 Burma Road**City:** Oakland, CA 94607**Report No:** WIR-028083**Date Inspected:** 23-Jul-2012**Project Name:** SAS Superstructure**OSM Arrival Time:** 700**Prime Contractor:** American Bridge/Fluor Enterprises, a JV**OSM Departure Time:** 1730**Contractor:** American Bridge/Fluor Enterprises, a JV**Location:** Job Site**CWI Name:** See below.**CWI Present:** Yes No**Inspected CWI report:** Yes No N/A**Rod Oven in Use:** Yes No N/A**Electrode to specification:** Yes No N/A**Weld Procedures Followed:** Yes No N/A**Qualified Welders:** Yes No N/A**Verified Joint Fit-up:** Yes No N/A**Approved Drawings:** Yes No N/A**Approved WPS:** Yes No N/A**Delayed / Cancelled:** Yes No N/A**Bridge No:** 34-0006**Component:** OBG**Summary of Items Observed:**

## WELDING INSPECTION REPORT

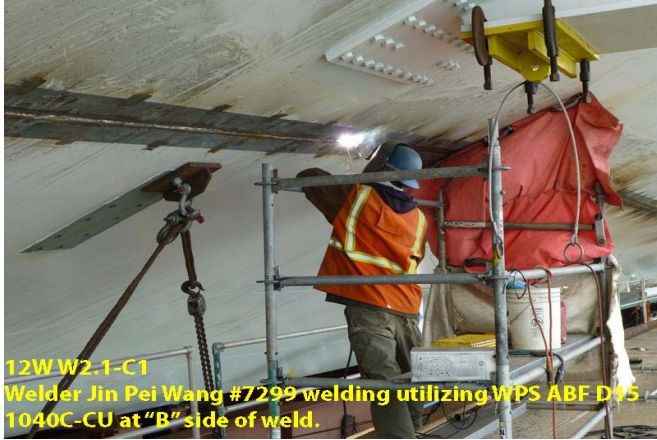
This QA randomly observed ABF/JV qualified welder Jin Pei Wang #7299 and AB/F JV Welder foreman James Zhen #6001 performing Shielded Metal Arc Welding (SMAW) with 3.2mm diameter E7018H4R electrode and implementing Caltrans approved Welding Procedure Specification's (WPS) ABF-WPS-D15-1040C-CU. The joint being welded was the E corner drop in external weld designated as 12W W2.1-C1 on side "B".

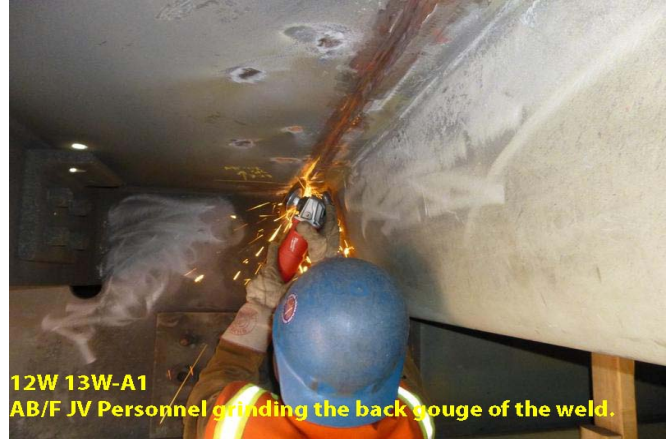
This QA randomly observed ABF/JV personnel prepare the back gouge of weld 12W-13W-A1 by grinding the back gouge creating U groove for the 4G welding of the deck weld between Panel Points 117 and 117.5 and between LS3 and LS4 deck plating stiffeners.
